### GENERAL INFORMATION:

Name of Operator:	ASL Flight Training School
Aircraft Manufacturer:	Cessna Company
Aircraft Model:	Cessna 172M
Nationality and Registration Marks:	8R-AFS
Place of Accident/Region:	Cheddi Jagan International Airport, Guyana – 062956.149N 0581515.670W
Date of Accident:	27 <sup>th</sup> March 2017.
Time of Accident:	16:45hrs UTC

### REPORT No. GAAIU 3/1/14

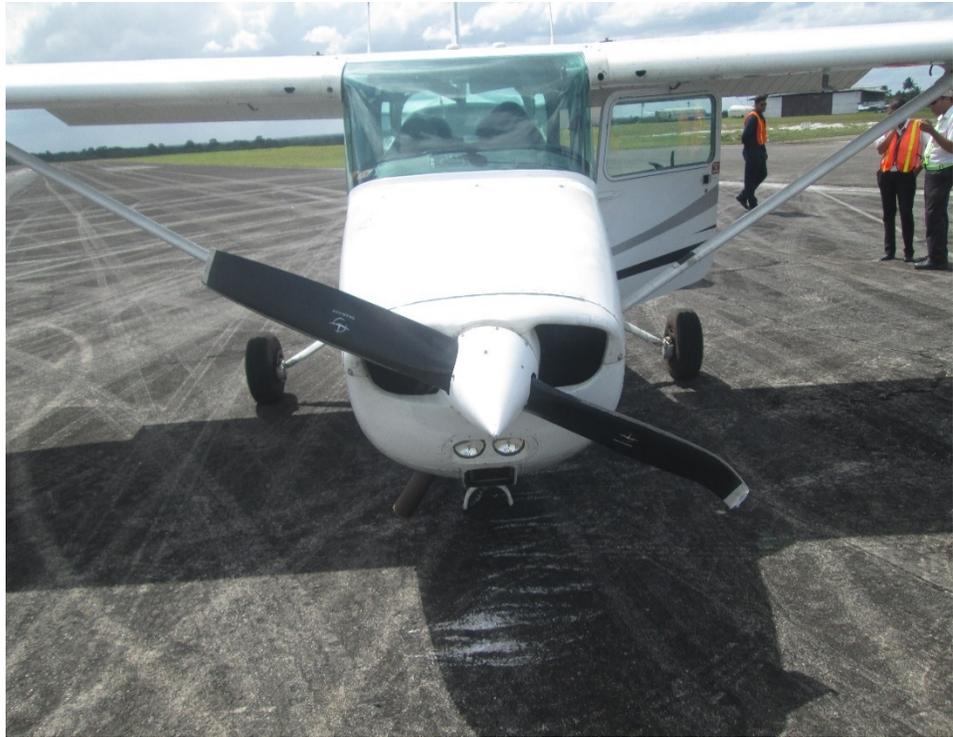
The aircraft touched down on its nose wheel which became separated from the nose wheel fork. The aircraft continued travelling along the runway, skidding on the nose wheel fork. This resulted in the nose wheel fork being eroded to approximately half its original length. The nose oleo strut was fully decompressed. Both propeller blades were broken at the tips. The engine and propeller suffered from the sudden stop. The propeller and the nose landing gear suffered extensive damages.

Picture #1 – showing damage to nose wheel fork and propeller blades
