**TITLE**

Name of Operator:	Oxford Aviation Incorporated
Aircraft Manufacturer:	Cessna Aircraft Company
Aircraft Model:	U206C
Nationality and Registration Marks:	8R-GMP
Place of Accident/Region:	Ekereku Bottom Airstrip/Region#7, Guyana - 06 24 01.05N 060 51 14.46W
Date of Accident:	12 <sup>th</sup> November 2015
Time of Accident:	18:05hrs UTC

**REPORT No. GAAIU:3/1/8**

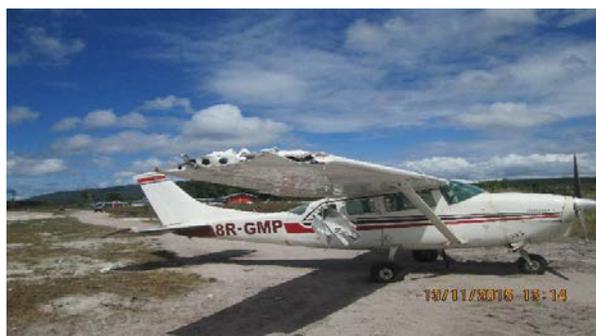
The upper and lower skin surfaces of the right wing of the active aircraft had damage extending from the wing tip to the second rib. The wing tip was missing and was later located in the left wing of the stationary aircraft.

Picture No.1: Showing damage to active aircraft

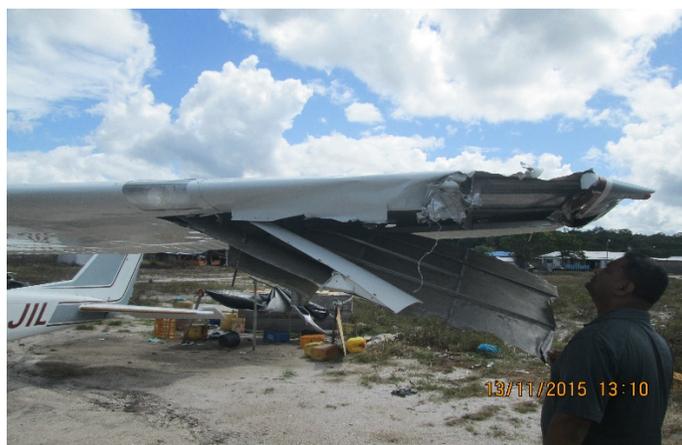
The skin of the lower left wing surface of the parked Cessna 172 aircraft was peeled back from the wing tip to the 4<sup>th</sup> rib inboard and the skin and ribs were left hanging. There was no other visible damage to this aircraft.

Picture No.2: Showing damage to the parked aircraft

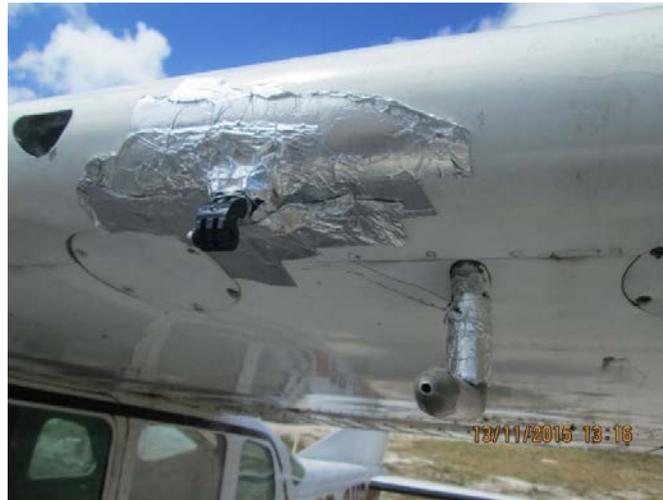
Inspection by the accident team revealed that the speed tape used to secure the camera was unevenly affixed to the wing. However, the pilot said that he was not aware that this could affect airflow over the wing of the aircraft. He was also not aware that hampering/interrupting airflow through the pitot tube could result in unreliable readings from the pitot/static instruments in the cockpit.

Picture No. 3: Showing Speed Tape and Safety Wire used to attach the Go-Pro Camera to the leading Edge of the Left Aircraft Wing

The pilot's unauthorized installation of the Go-Pro camera was both illegal and dangerous. The fact that he installed it on the left wing leading edge and near to the pitot tube is cause for concern, as it questions his understanding of aircraft instruments systems. He is also in breach of GARs 5.5.3(a) which prohibits anyone from performing unauthorized modifications to any aircraft. He failed to recognize the adverse effects that could result from disturbed airflow over the aircraft wing and its possible effects on the aerodynamics of the aircraft operations. He also failed to recognize that even partial blockage of the pitot tube could adversely affect the readings of the static instruments in the aircraft including the airspeed indicator and the altimeter. This therefore means that he also violated GCARs paragraph 28(6), which states that equipment shall be installed so as not to be a source of danger .... or to impair the proper functioning of any equipment .... necessary for safe functioning of the aircraft. It was noted that the pilot was just four years out of flight school and his failure to recognize the danger of disturbing the RAM airflow is not acceptable. He was urged to continuously review his training manuals in order to ensure that his knowledge remained up to date.

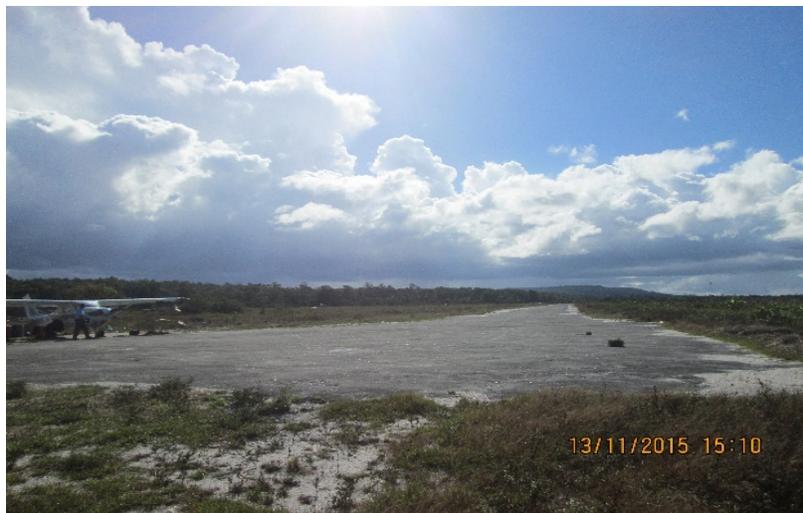
The other aircraft which was damaged in this accident was found parked off the turnaround area, with its nose wheel 1 foot from the edge of the runway with the nose cone protruding about 2ft over the turnaround area. This was 46ft from the extended center line of the runway. The diameter of the turnaround area is 96ft. During the inspection it was observed that there were several drums and large heavy metal objects that appeared to be mining equipment, just behind this aircraft.

Picture No. 4: Showing Position of Parked Aircraft

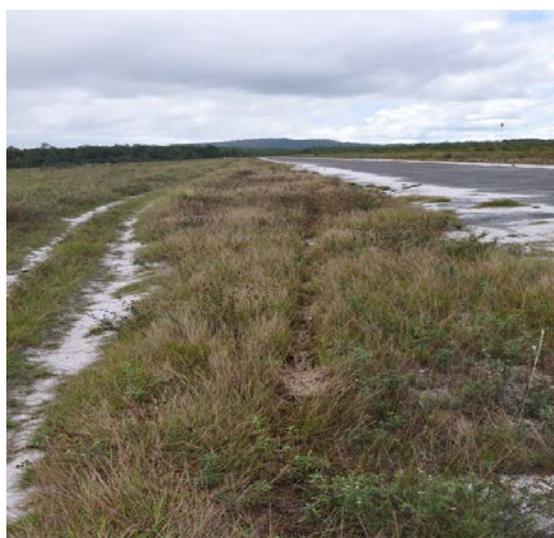
Investigation of the identified marks on the runway confirms that there were two sets of tracks beginning at about the same spot. Shortly after touchdown, one set of tracks diverted further right so that the track of the right undercarriage was clearly visible in the grass on the runway shoulder. The left main wheel track was evident on the runway.

Picture No. 5:- Showing the Track of Right Under Carriage on Right Side of Runway
