**TITLE**

Name of Operator:	Oxford Aviation Incorporated
Aircraft Manufacturer:	Cessna Aircraft Company
Aircraft Model:	U206C
Nationality and Registration Marks:	8R-GMP
Place of Accident/Region:	Ekereku Bottom Airstrip/Region#7, Guyana - 06 24 01.05N 060 51 14.46W
Date of Accident:	12 <sup>th</sup> November 2015
Time of Accident:	18:05hrs UTC

**REPORT No. GAAIU:3/1/8**

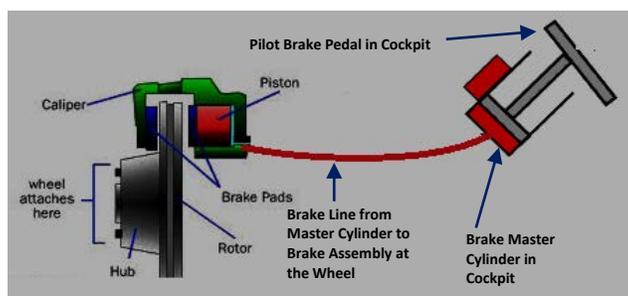
Diagram No.1 – Schematic of Cessna 206 Brake System

The brake is a direct, non-powered closed hydraulic system. It is self-contained and has hydraulic brake lines running from the master cylinders in the cockpit to individual brake calipers mounted to each main wheel assembly.

The landing gear includes a parking brake system and a non-powered ground steering system that is operated by the rudder pedals.
